# 2024 年宁夏极端暴雨事件引发的梯田侵蚀调查研究

**摘要:** [目的] 探究极端暴雨事件对宁夏回族自治区不同区域梯田侵蚀程度的影响及其发生机制, 为梯田优化设计与水土保持建设提供科学依据。[方法] 基于降水量空间异质性, 沿宁南至宁北暴雨带建立调查样带。以受 2024 年宁夏大范围极端暴雨事件影响的 9 个小流域为对象, 通过遥感解译、实地测量与田间调查, 解析不同梯田侵蚀类型(沟蚀、坎坡崩塌等)的空间分异规律, 定量评估梯田侵蚀量, 探究侵蚀驱动因素(降雨强度、田坎坡度、田埂完好程度、地势因素)。[结果] 调查区域内, 梯田侵蚀类型以冲沟、崩塌、切沟为主。梯田侵蚀集中发生于整座坡面下部 30% 的梯田群; 不同类型梯田因其设计标准、保存质量等不同, 其侵蚀量也存在差异, 老式及坡式梯田侵蚀较为严重。流域梯田侵蚀强度呈现区域分异, 泾源县照明流域(7 080 t/km<sup>2</sup>)侵蚀强度最强, 同心县(41.41 t/km<sup>2</sup>)最弱; 同心县水井沟流域梯田保土量最高(3.48×10<sup>4</sup> t/km<sup>2</sup>)。[结论] 梯田侵蚀受地形、水文、工程协同作用影响, 其侵蚀强度与保土能力的空间分异受自然因子直接驱动与工程建设(田坎坡度、田埂修缮)间接调控。标准化田坎工程结合植被缓冲带可提升梯田抗蚀能力。

## Investigation and study on terrace erosion caused by 2024 extreme rainstorm event in Ningxia Hui Autonomous Region

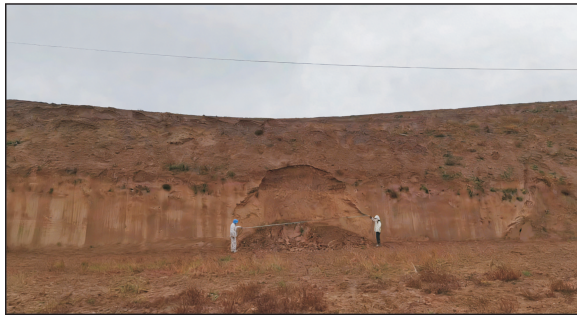
a<sub>1</sub> 复式埂坎梯田(实景图)

田工程质量好,标准高,地块宽大,田面平整略有向内反坡,埂坎坚实,能有效控制水土流失<sup>[11]</sup>。其中调查区域内主要存在复式埂坎式、削坡复式两类新式梯田(图1);老式梯田田面窄短陡洼,形态完全根据山体的坡度,田坎就地取材,地块狭小分散,无法进行大规模机械化作业<sup>[12]</sup>;坡式梯田田面不平,田坎通常较低矮,多用泥土或草皮简单垒砌,结构相对简单,分布于坡度较陡、地形破碎的地区<sup>[13]</sup>。受损类型和损毁长度等关键损毁指标,通过实地勘测明确侵蚀类型(侵蚀类型分类标准参考水土保持学概论<sup>[14]</sup>)及发生原因,以评估各类梯田的侵蚀情况。根据流域面积在流域内均匀选取10~20处坡耕地进行细沟侵蚀调查,从“qsdk.shp”数据中筛选面积较大的坡耕地(前75%),随机选取3~5块作为样本。在每个样本中划出10 m宽的样带(有浅沟时按实际宽度),沿坡面设置5~7条测量断面。野外测量时用3把卷尺定位,记录每条细沟的长、宽、深。遇到坡度变化处单独设置测量样带。并计算细沟侵蚀量,用于流域梯田保土量计算。

图 1 调查区域新式梯田实景与模型图

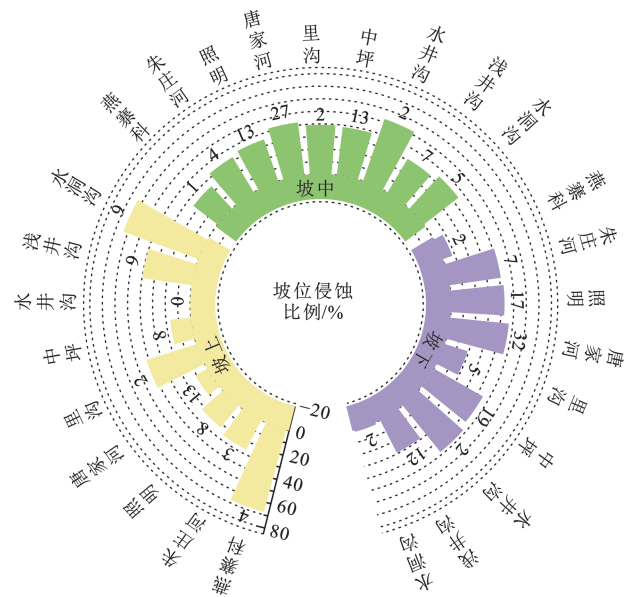
基于实地调查与 RTK 空间定位影像,标记每个侵蚀所在位点,并对梯田各部分侵蚀数量进行统计(图 3)。唐家河下游流域发生的侵蚀数量最多(72 处),水井沟流域发生的侵蚀数量最少(4 处)。各流域梯田侵蚀主要集中在整座坡面的下部梯田群,侵蚀量呈:下部梯田群>上部梯田群>中部梯田群的分布趋势。实地调研发现,梯田上部梯田群以切沟溯源侵蚀伴随基部掏蚀为主(即冲沟、落水洞侵蚀),下部梯田群则表现为渗透软化和表层剥蚀为主(即冲沟、崩塌、滑坡侵蚀)。此外,唐家河下游流域

28 号耕地的中下部梯田条带间出现了连级侵蚀现象。上层梯田水流突破田埂后,地表水流逐级递增,致使下游梯田侵蚀量增加,发生连续冲沟侵蚀,最终形成贯穿坡面的连续侵蚀沟。

图 3 调查区域内梯田上、中、下各部分侵蚀数量及侵蚀量比例

地势条件是影响梯田侵蚀发生位置的关键因素。坡度增大直接强化了径流剪切力,导致侵蚀量显著增加<sup>[26]</sup>。在不同类型梯田中,侵蚀分布存在差异。调查发现,水洞沟与燕寨科流域的坡式梯田以上部梯田群侵蚀量比例明显高于下部梯田群(图 3)。研究<sup>[27]</sup>表明,顺坡方向上总侵蚀速率总体呈波动下降趋势。新修机修梯田(如浅井沟主沟和里沟流域)因田埂结构松散,易在雨水汇集处发生局部侵蚀,整体风险较高<sup>[10]</sup>。其上部梯田群更易发生冲沟侵蚀,细颗粒在持续降雨中向下迁移,导致底部梯田群流失量常低于顶部<sup>[28]</sup>。但也有研究指出,因下部汇水累积效应更强,整座梯田自上至下的侵蚀量可能呈递增趋势<sup>[29]</sup>,朱庄河、中坪和照明流域即符合该规律(图 3)。而唐家河下游与水井沟流域中下部梯田群侵蚀更严重(图 3),可能与整座梯田上部和下部的相对高差和汇水面积有关<sup>[30]</sup>。暴雨条件下,上部梯田

群因汇水面积较小,难以形成集中股流;而中下部梯田易发育细沟,这些细沟沿坡面延长,并通过合并与分叉作用不断拓宽和向深层发育,因此侵蚀主要集中于中下部梯田群<sup>[31]</sup>。土壤质地是影响梯田抗侵蚀能力的另一重要因子。老式梯田长期耕作导致有机碳减少、团聚体稳定性降低、容重上升<sup>[32]</sup>,抗蚀性下降,下渗减少、径流和剪切力增大,从而更易发生冲

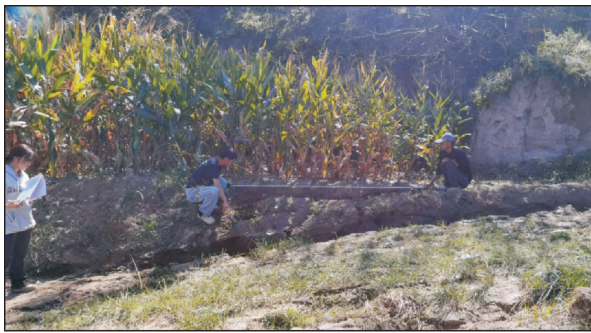
在黄土高原陡坡地带修筑宽幅梯田,需配套更宽道路与更高田坎,这降低了边坡稳定性与阶梯结构抗蚀能力,也提高了崩塌灾害的风险<sup>[22]</sup>。不合理的田坎设计在暴雨中易引发连续边坡侵蚀与田坎侵蚀,且梯田近路侧常见局部洼陷,导致径流异常汇集,加剧边坡冲刷与田坎崩塌。降雨还可能诱发边坡垮塌,改变汇流路径,使水流导向路面。道路作为输沙通道,将上方梯田的径流和泥沙输送至下方,促成连续边坡侵蚀<sup>[23]</sup>。唐家河下游流域出现田坎连续侵蚀现象。观察其径流痕迹发现,径流溢至田坎时,发生强烈冲刷,田坎出现贯通上下田面的侵蚀沟<sup>[24]</sup>。在两种新式高标准梯田中,复式埂坎式梯田(由缓坡与垂直坡复合构成田坎)发生侵蚀较多,其径流于缓坡坎汇集并冲刷坎体,尤其在缓坡与垂直坎交界处受集中水流冲击,易引发冲沟和崩塌侵蚀。而削坡式梯田(采用田埂叠加垂直田坎结构)则在田面径流冲毁田埂后,在田坎下部汇流,进而形成落水洞等侵蚀。实地调查表明,照明流域存在大量不合理滴灌铺设(图 4),导致该区域侵蚀严重,在暴雨条件下加剧侵蚀发生。同时该区种植盆栽崧蓝会降低土壤蓄水能力,暴雨冲刷致使滴灌带暴露损坏,加重侵蚀。此外,尽管玉米地覆膜具有抗侵蚀性,但阻止了径流下渗<sup>[25]</sup>,在强降雨条件下,膜面汇流增加地表径流,造成梯田侵蚀加剧。

a 道路汇水造成的侵蚀

图 4 调查区域内人为因素造成的侵蚀

调查发现,缓坡石坎抗蚀性优于陡坡土坎。因此,梯田建设中应依据坡度合理选择田坎类型,陡坡区宜采用石砌或混凝土等坚固结构,并配合回填土夯实与坡面植草,以兼顾经济性与抗蚀能力。针对田埂基部易被冲刷的问题,建议加宽加高埂体、加强夯实,关键部位以石料镶边,埂顶设计为向内微反坡,并全面植草固土。同时应强化排水沟衔接处,及时修补裂缝,确保水流畅通,反坡田面或内倾排水沟均匀分散,避免集中冲刷。综合分析表明,整座坡面的下部梯田群侵蚀较为严重,主要是整座梯田缺乏有效的水沙调控措施,导致径流向下汇集能量增强。故应以综合治理为原则,在整座坡面上部修建截水沟(缓冲径流的作用)<sup>[10]</sup>中部设置反坡田面(内倾 $3^{\circ}\sim 5^{\circ}$ 可减少 71% 的径流<sup>[9]</sup>)下部建设分级排水与导流槽系统,实现径流逐级消能,从而减轻下部侵蚀<sup>[33]</sup>。同时,滴灌技术具备节水减蚀能力,但不合理铺设会加

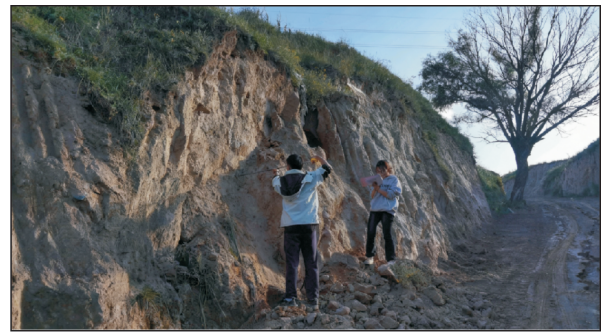
b 边坡侵蚀

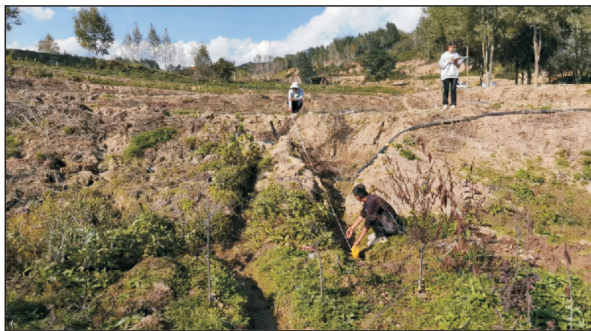
c 不合理灌溉造成的侵蚀

剧局部侵蚀。建议将滴灌管理设至 25 cm 深度并进行锚固,以防暴雨冲刷导致裸露<sup>[34]</sup>。

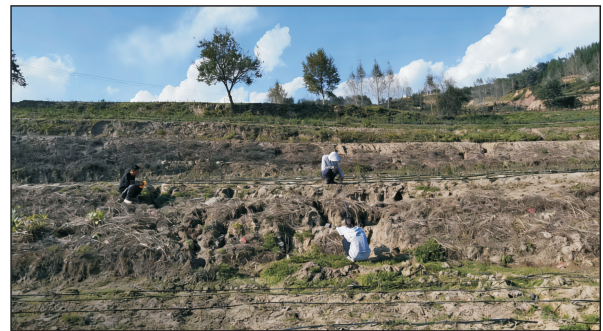
Fig.4 Erosion caused by human activities in survey area
